Buffalo HT Fan has the solution

Replacing broken cast hub assembly saves wheel from the scrap pile ! Saves \$\$\$ too!

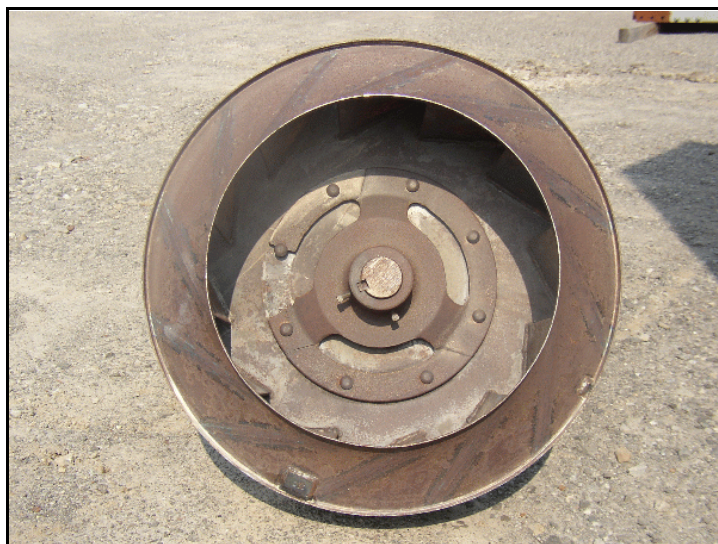
- A repeat Buffalo HT Fan customer was experiencing vibration problems with a fan on a calciner process.
- During an unscheduled shutdown, they opened the fan housing and discovered that the cast hub assembly was almost completely broken apart. Additionally, the backplate was severely cracked where the rivets held on the cast hub.
- The customer contacted Buffalo HT Fan to see if it could be repaired or replaced during their short outage.
- Buffalo HT Fan Co. ASME certified welders removed the broken hub, and repaired the cracked backplate, fabricated and installed a new hub, stiffening plate, gussets and hub cone, and repaired the shaft in less than 48 hours.

The fan wheel and shaft was balanced as an assembly to ISO G2.5 (turbine) Grade specs for smooth running at very high speed.

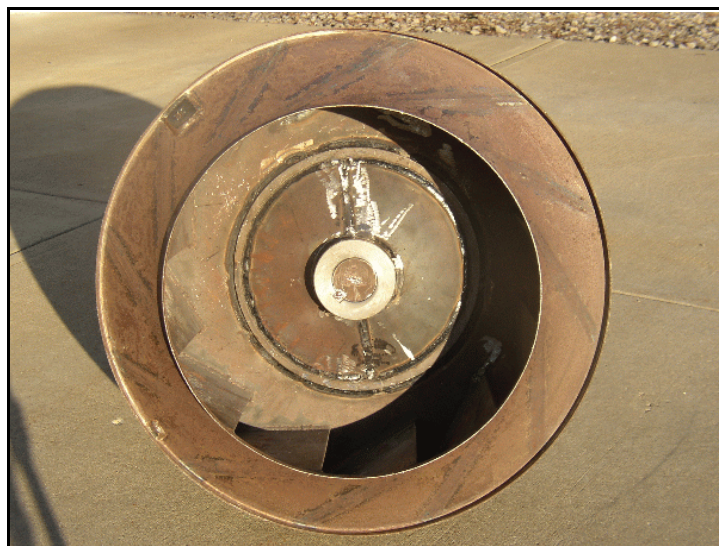
- The rebuilt wheel was completed and delivered on time, as promised.
- Buffalo HT Fan's fabricated hub cone (100 % fabricated, NOT cast) is much stronger than the original hub design.
